CONNECTICUT RIVER BASIN
LEYDEN , MASSACHUSETTS

UPPER GLEN (GREENFIELD) RESERVOIR DAM
MA 00049

PHASE I INSPECTION REPORT
NATIONAL DAM INSPECTION PROGRAM

MARCH 1981

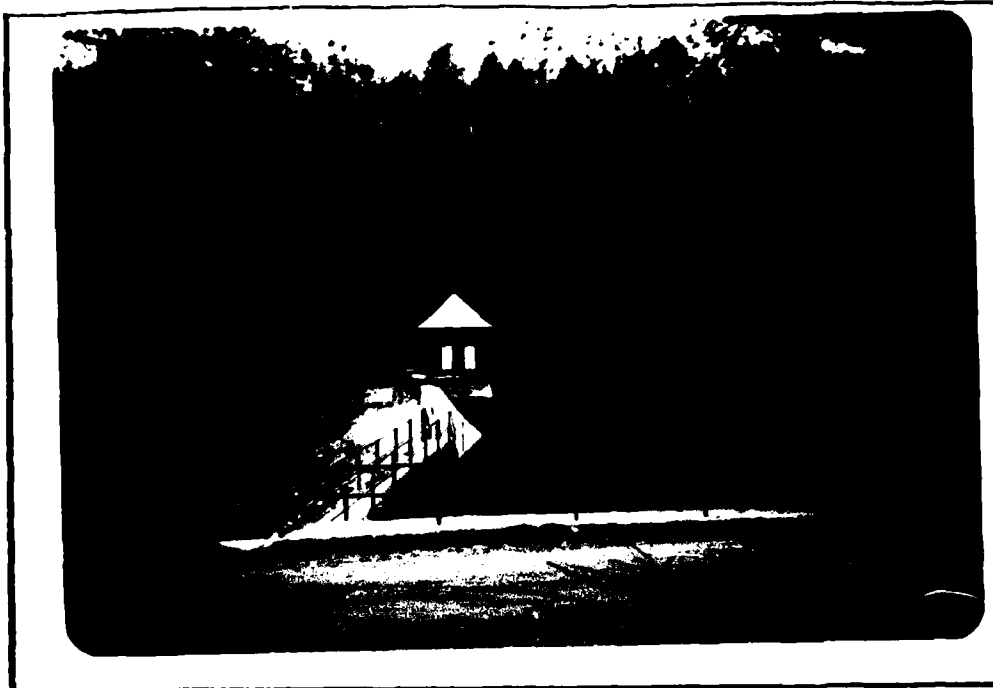
UPSTREAM OVERVIEW OF THE DAM FROM THE LEFT ABUTMENT.
(12/3/80)

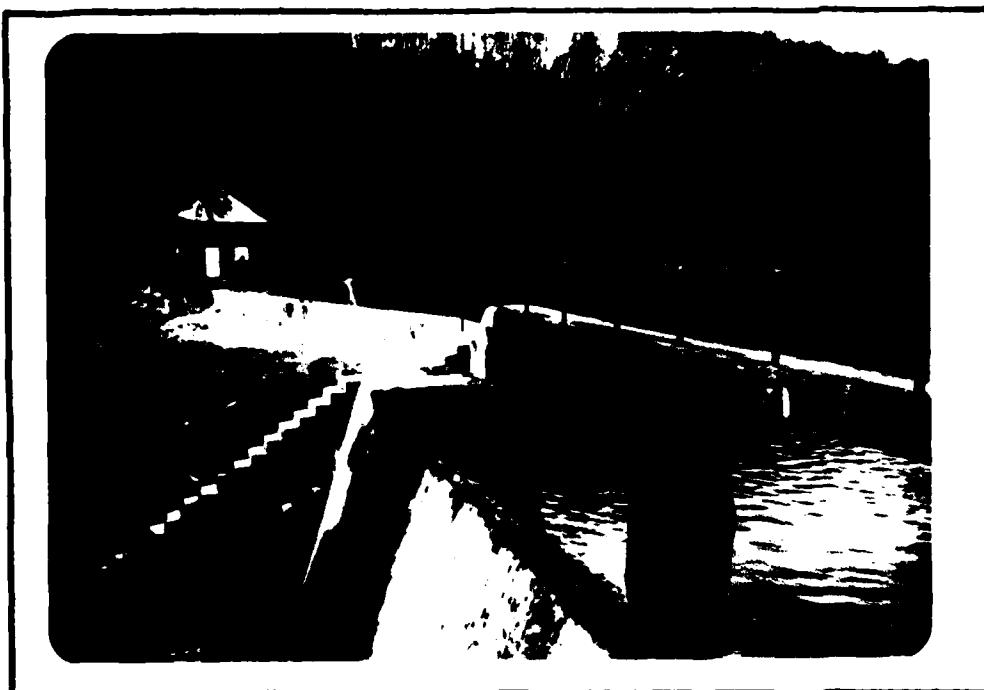
DOWNSTREAM OVERVIEW OF THE DAM FROM THE LEFT ABUTMENT.
(12/3/80)

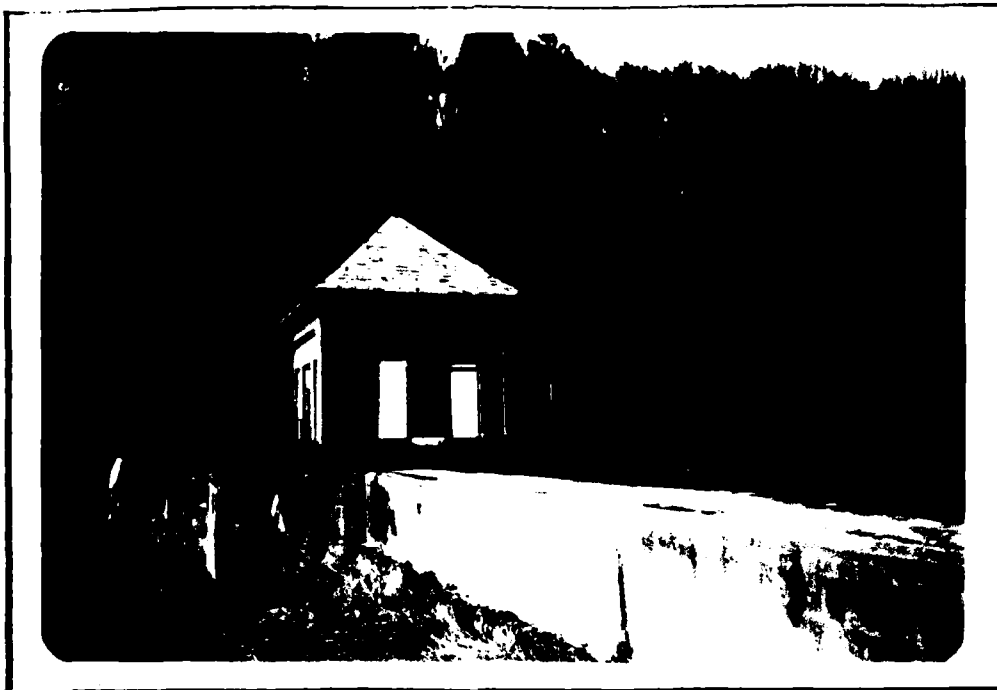
1. CREST OF DAM SHOWING GATE HOUSE, HOIST PLATFORM AND HOIST, AND CONCRETE WALL. (12/3/80)

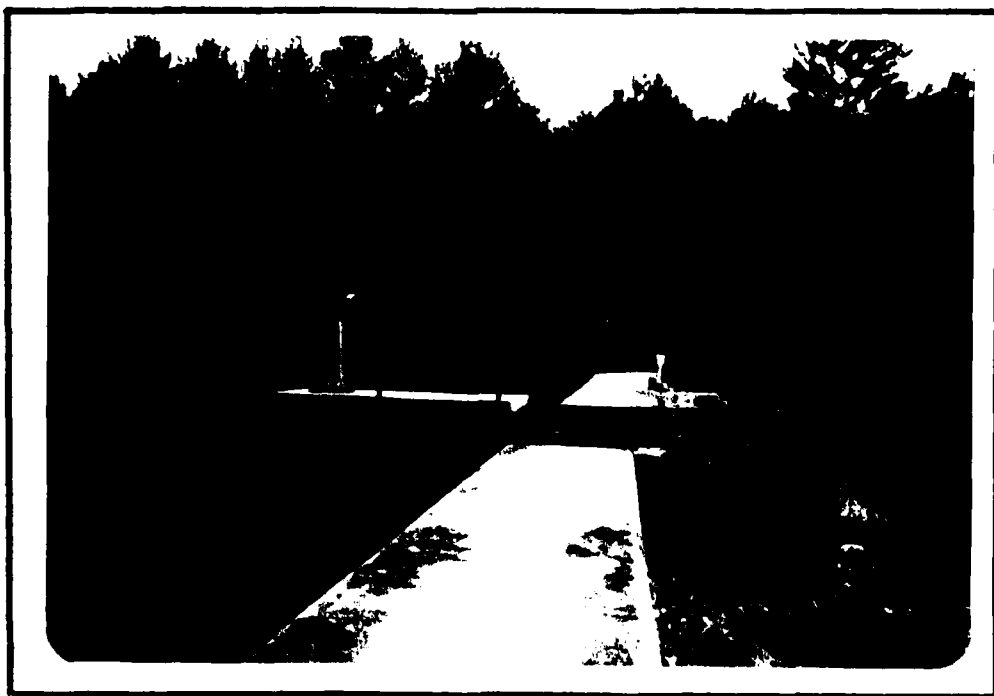
The access bridge to the operator for the 24-inch diameter low-level outlet appears to be in good condition. As shown in photo number 2, it appears to have been recently painted. According to Mr. Richard Michand, Water Foreman, the crank and the worm gear for the operator have been removed to prevent unauthorized operation. For a more detailed description of the outlet works, refer to Section 1.2b.

2. CLOSE-UP OF HOIST PLATFORM AND HOIST. (12/3/80)

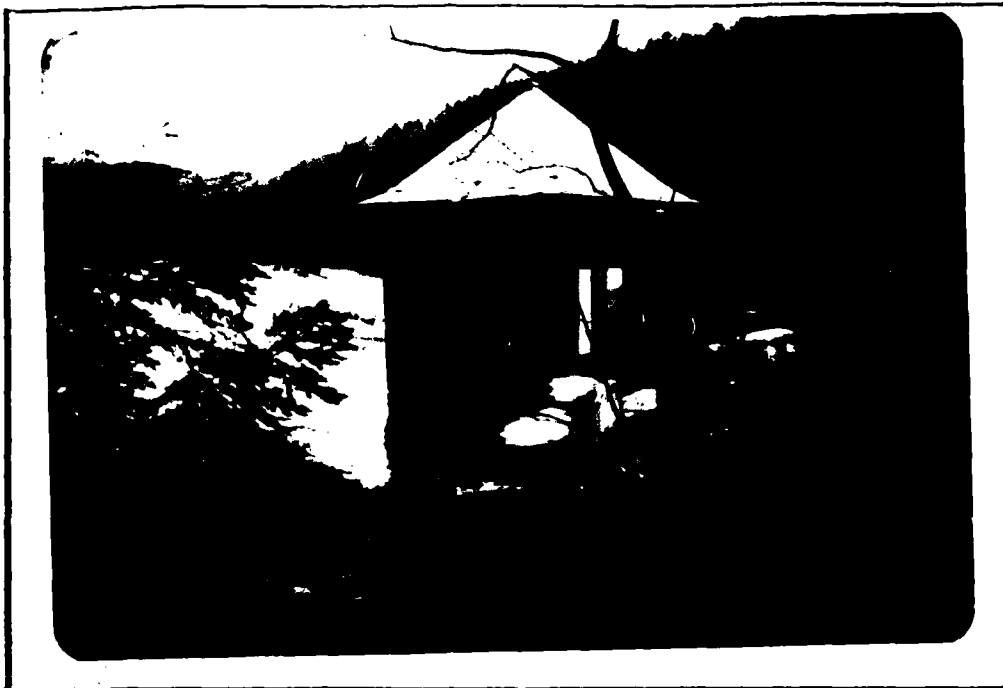
3. GATEHOUSE AND IMPOUNDMENT AS VIEWED FROM THE RIGHT ABUTMENT. (12/3/80)

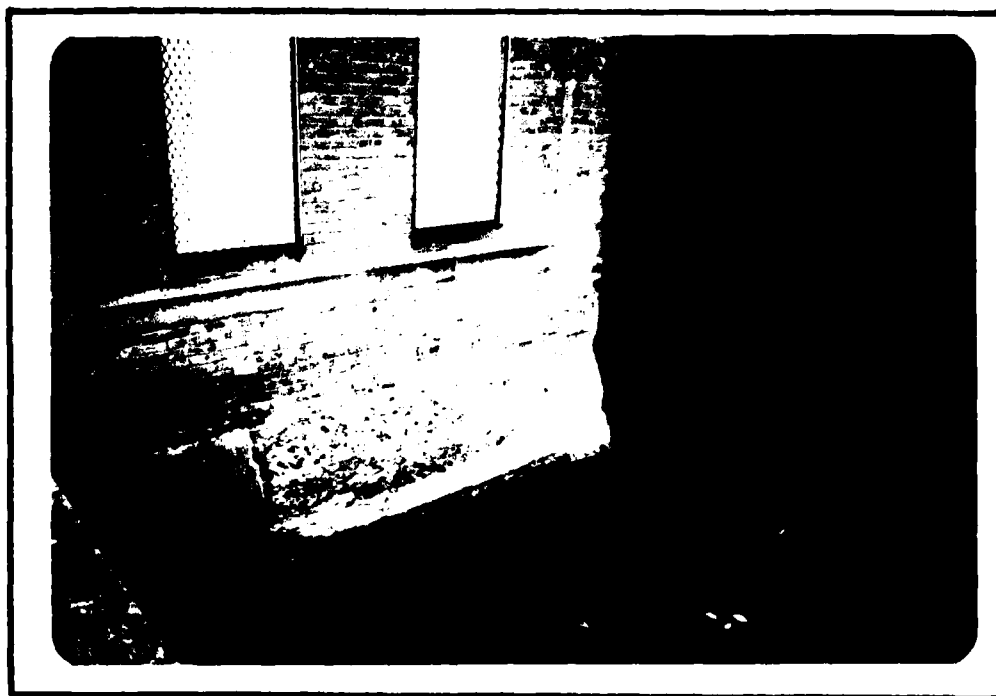
c. Appurtenant Structures. A brick gatehouse is located approximately 50 feet in from the west abutment. It has a concrete foundation with some surface spalling observed above the water surface (see Photo 4 in Appendix C), but overall appears to be in fairly good condition. The windows have been replaced with plywood panels to help discourage vandalism. The sluice gates in the gatehouse were replaced in 1975; therefore, they appear to be in very good condition. Intake bars located on the north wall of the gatehouse have three-inch spacings.

Some concrete spalling was observed along the access walkway over the spillway and on the foundation walls of the gatehouse. Local displacement of stones was observed along the downstream face of the dam. These conditions are not considered serious.

4. CLOSE-UP OF THE GATEHOUSE. (12/3/80)

4. Repair the spalled concrete on the foundation walls of the gatehouse and on the access bridge over the spillway.

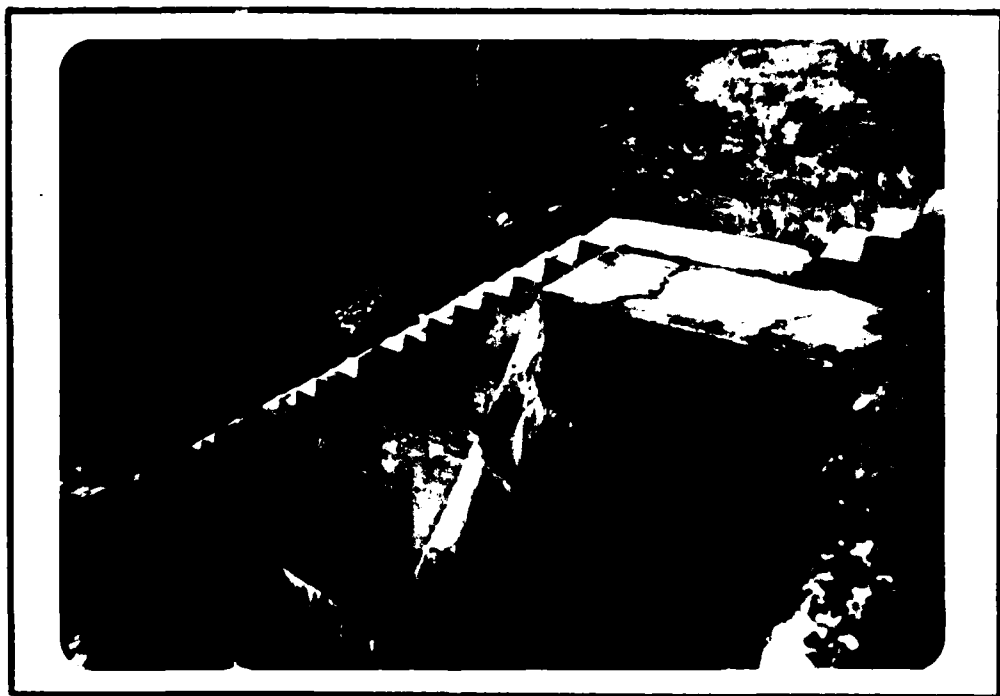
A 45-foot long spillway is located at the east abutment. It consists of a 10-foot wide, broad crested masonry weir and a very steep rock cut discharge channel which follows along the east abutment of the dam. The east side of the spillway is bordered with coniferous trees, as is the west side of the spillway channel below the toe of the dam. The west side of the spillway is formed by a concrete retaining wall which shows evidence of cracking in many locations from the bottom to the top of the spillway. From observation it is not possible to judge how deep the cracks may extend. The largest cracks in the vicinity of the top of the wall appear to be about 0.25 inches. (See photo 6 in Appendix C.)

The concrete retaining wall along the west side of the spillway is cracked in many locations from the bottom to the top of the spillway (See photo 6, Appendix C). From observations it is not possible to judge how deep the cracks may extend. The largest crack in the vicinity of the top of the wall appears to be about 0.25 inches.

6. SPILLWAY EXIT CHANNEL AS SEEN FROM THE WALKWAY OVER THE SPILLWAY. (12/3/80)

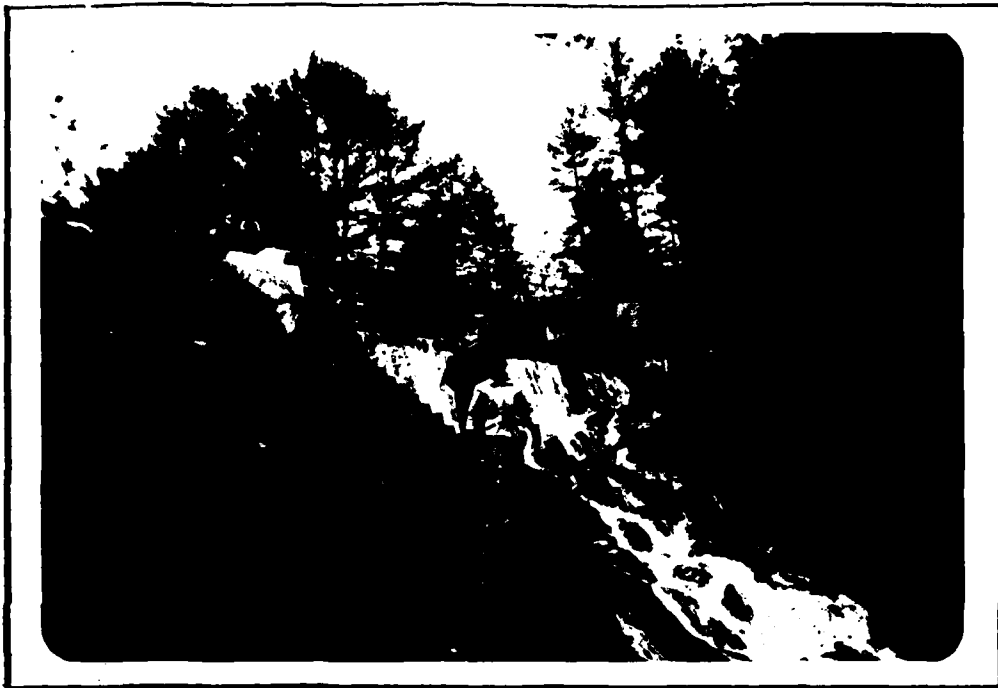
7. LOOKING UPSTREAM ALONG THE SPILLWAY EXIT CHANNEL. (12/3/80)
